## **SR 3 MP 49.48 Big Scandia Creek (996804): Preliminary Hydraulic Design Report**

**JULIE HEILMAN, PE (FPT20-03166)  
STATE HYDRAULIC ENGINEER  
Y-12554 Olympic Region GEC**

**Sulochan Dhungel, P.E., Lead Design Engineer,  
David Evans and Associates, Inc. (FPT20-37787)**

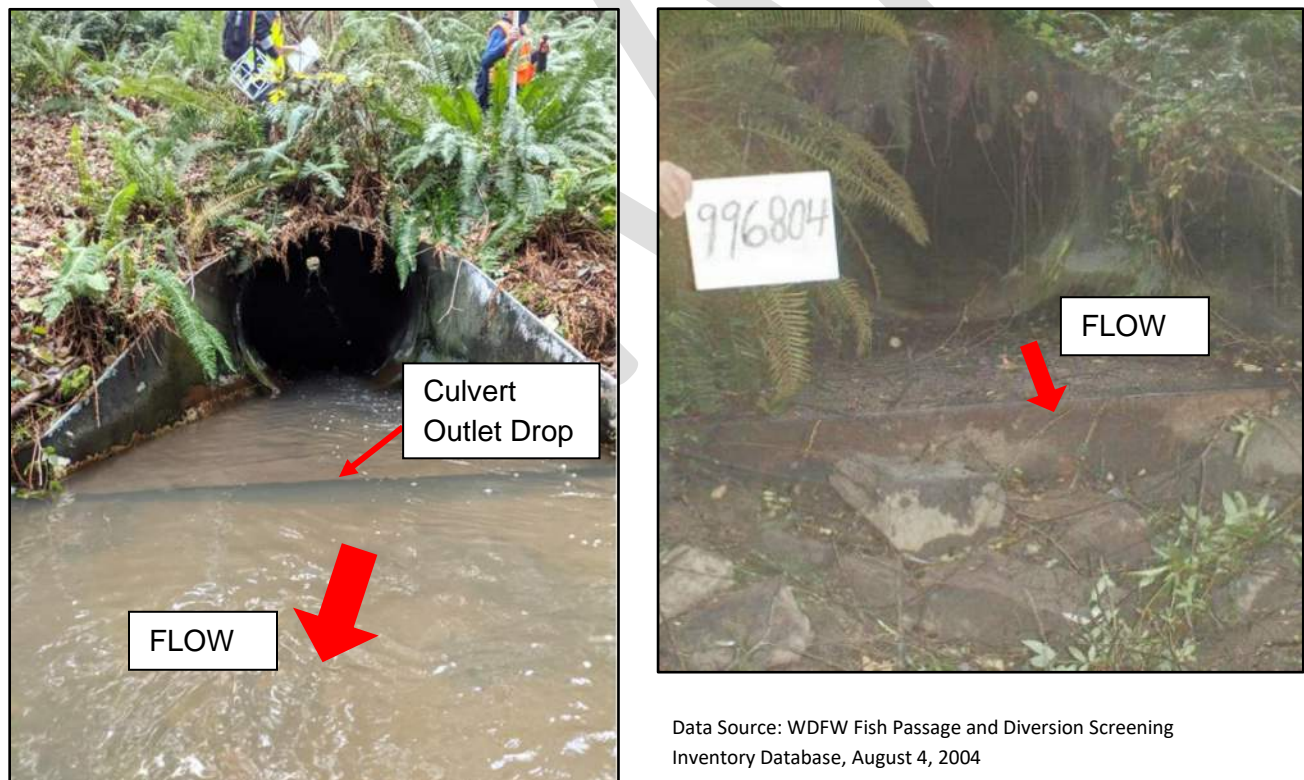
The culvert under SR 3 at MP 49.48 (Site 996804) for the Big Scandia Creek is listed as a barrier due to outfall drop. The outfall at the downstream side drops by 0.8 foot. This drop restricts salmonid migration up and down the stream. Fine sediments settle in the pool created by the drop, and eddies in the pool scour the channel at this section, releasing sediments into the system. This crossing is not listed as a Chronic Environmental Deficiency or failing structure (WSDOT 2020). There was no visible maintenance activity noted during the site visit, and no maintenance records were available. Flooding history of the site was not available in any relevant reports and literature, and no high-water marks were evident around the site. The total length of potential habitat gain for Site 996804 is 6,312 linear feet according to the WDFW Fish Passage and Diversion Screening Inventory Database (FPDSI, 2021) for this site.

**Figure 7: Outlet of existing 54-inch CMP culvert with pool formed at the drop (approx. STA 2+00)**

The section of channel immediately downstream of the culvert approximately between Station 2+00 and Station 1+70 has a slope of about 0.9 percent. This section has the channel drop of 0.8 feet which causes this crossing to be a barrier for fish passage. Overall, on the downstream section, along the channel length, clusters of woody material cause small periodic drops of less than a foot at multiple locations (see Figure 21 and Figure 22). These drops, which were observed during the site visit on December 1, 2021, were swept away by a larger flood event and were not present on the subsequent site visit on February 3, 2022, as shown on Figure 22.

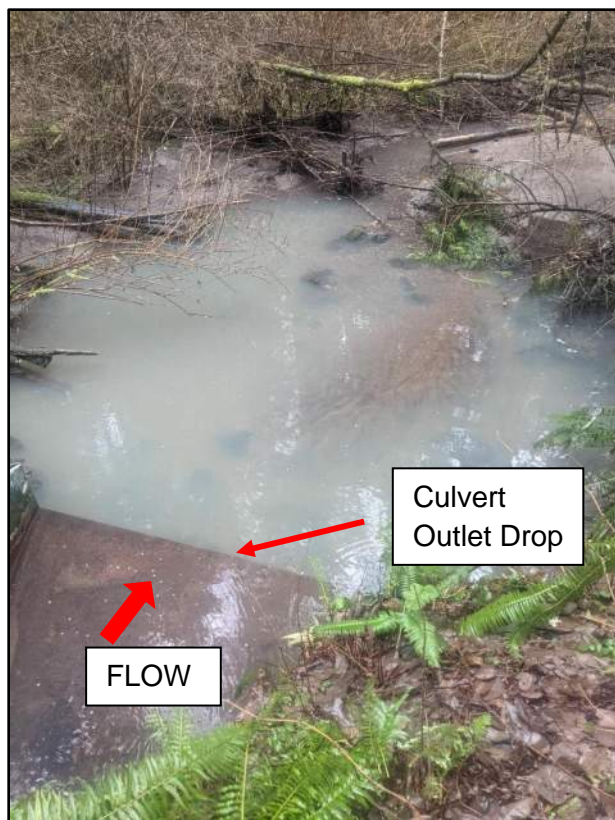
This crossing consists of one 54-inch round corrugated metal pipe (CMP) culvert that is 202.5 feet long (see Figure 7). The culvert inlet and outlet have metal flairs as wingwalls to support transition of flow through the culvert. The gradient of the culvert is about 1.5 percent, and it has a straight alignment through the highway fill. As-built information for the crossing was not available in the documents provided by WSDOT. This crossing has been identified by WDFW as a fish barrier due to water surface drop. The initial WDFW survey, conducted in 2004, shows that when the stream is dry there is a drop of about 0.8 foot caused by the metal flair that is part of the culvert structure (see Figure 7). During the DEA site visit, the stream had enough water to inundate this drop, so that the water surface level was equal on both sides. A pool was observed that has formed downstream of the drop (see Figure 7 and Figure 8). The turbidity observed in the stream could be a result of a recent storm in the area. High flows from the storm could have disturbed the fine sediments at the pool created by the drop and increased turbidity to the stream. Visual inspection indicates that the culvert appears to be in relatively good condition, with minor rusting along the invert (see Figure 9). There were no obvious signs of maintenance activity.

**Figure 8: Outlet of existing culvert (approx. STA 2+00)**

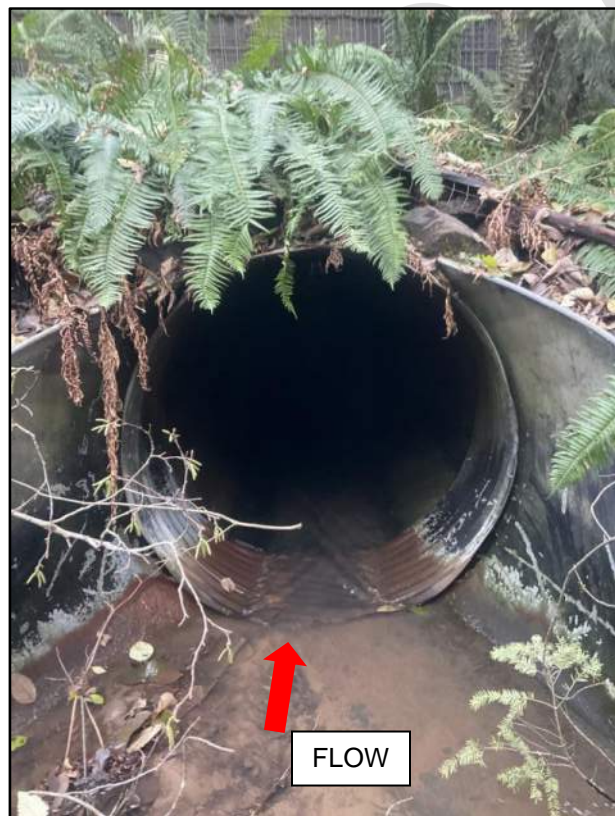
**Figure 9: View of culvert upstream (approx. STA 4+00)**

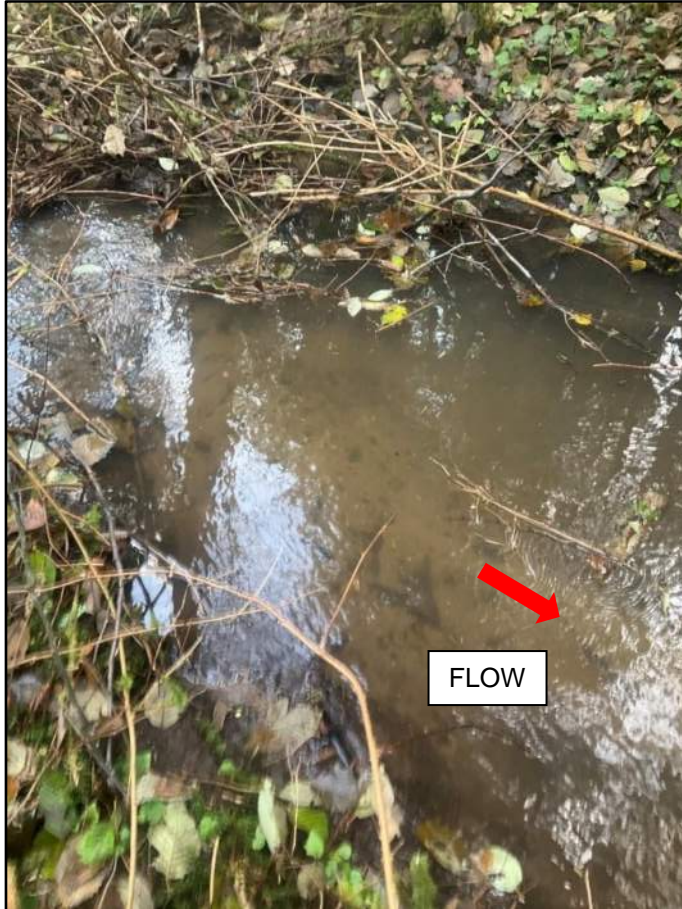
**Figure 13: Aggradation of fine sediment and organic matter near STA 5+40**

The channel morphology downstream of the reference reach appears to be influenced by vegetation that consists of red alder and salmonberry, resulting in a shallow channel with a channel bed consisting of fine material and organic matter (see Figure 27). Red alder and salmonberry are common in areas that have undergone disturbance that creates high light conditions; therefore, this vegetation is likely present due to the ground disturbance created during construction of the highway. The reference reach was selected as a location where the vegetation transitions to include mature cedars and ferns and where the channel is better defined.

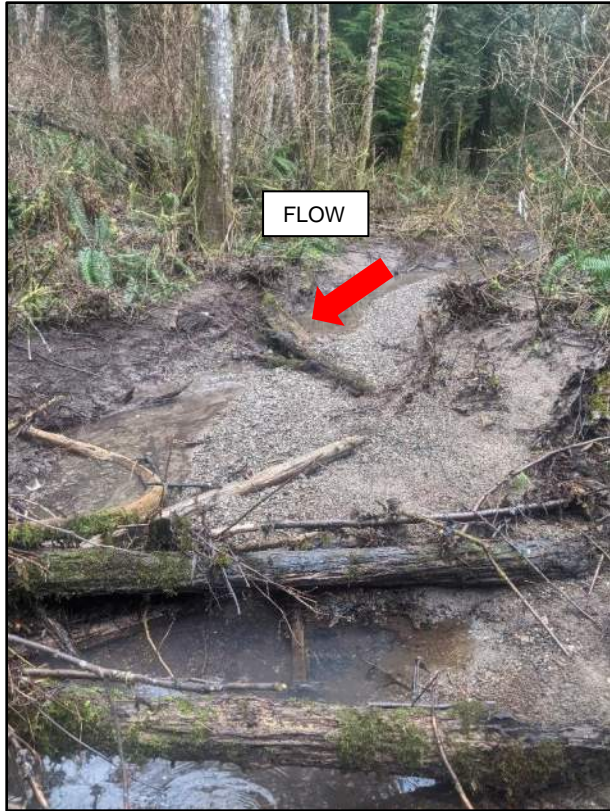
Farther downstream, approximately between Station 4+90 to Station 4+30, the channel has a slope of about 1.3 percent. The stream has another bend at this section to the south-east direction and due to this bend some energy is lost which causes lower velocities. There is presence of some woody material along the channel (see Figure 15). The vegetation in this section is still mostly salmonberry and ferns along the banks, while red alder is the prominent overstory vegetation. There are some woody materials present along the section (see Figure 16). Although the stream is mostly confined, flows in the channel at some locations in this section might have limited access to the overbanks during high flows (see Figure 16 and Figure 17).

**Figure 16: Woody material and channel bed material near STA 4+30**

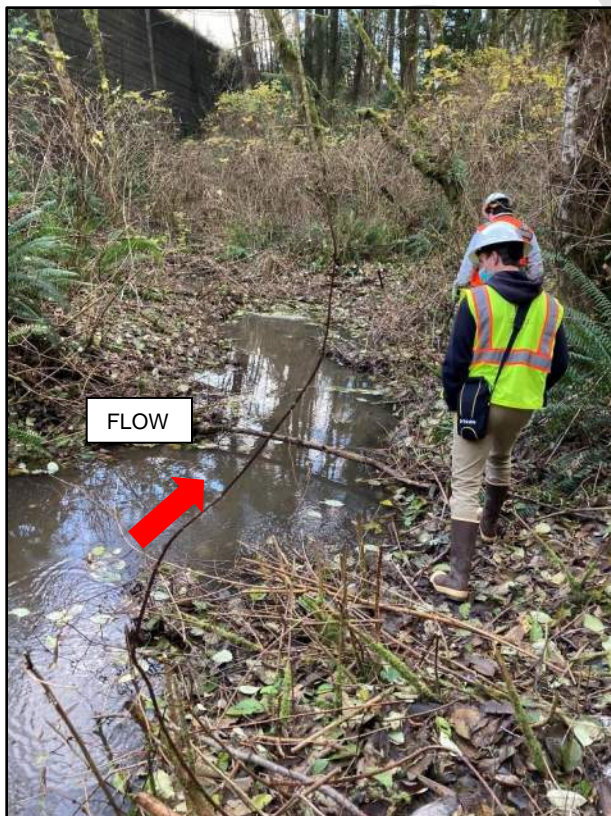
**Figure 17: Channel section near STA 4+50**

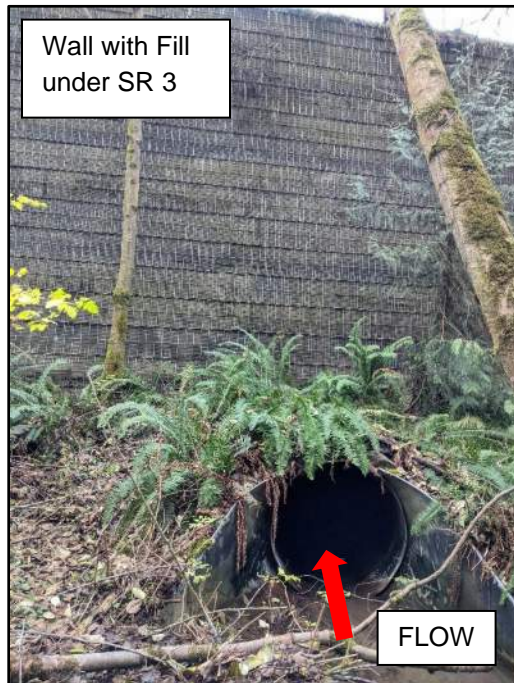
The section of channel approximately between Station 4+30 and Station 3+90 is immediately upstream of the culvert inlet. The slope was similar to upstream section of about 1.3 percent. Behind the culvert inlet, a large 30-foot retaining wall supports the SR 3 road fill (see Figure 18). The channel banks are not prominent along this section, and there is some LWM along with woody material (see Figure 19 and Figure 20).

**Figure 18: Wall with large fill height (approx. 30 feet) at the upstream side (approx. STA 4+00)**

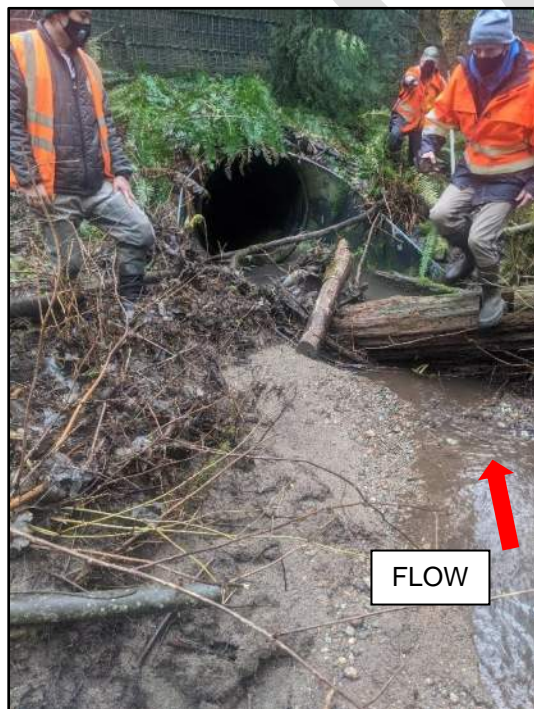
**Figure 19: Woody material and bed material along the channel upstream of the culvert (approx. STA 4+10)**

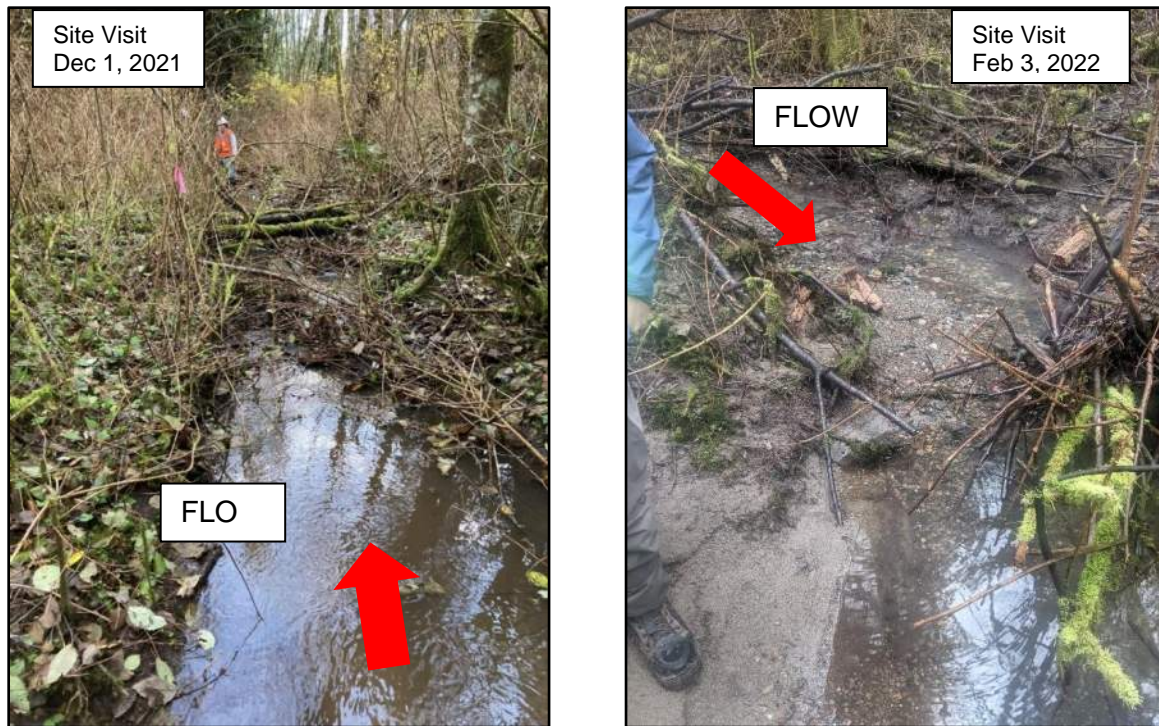
**Figure 22: Flow downstream of the culvert across confined sections, with small woody material at some sections (approx. STA 1+70) that is shifted by larger flood events (site visit Feb 3, 2022)**

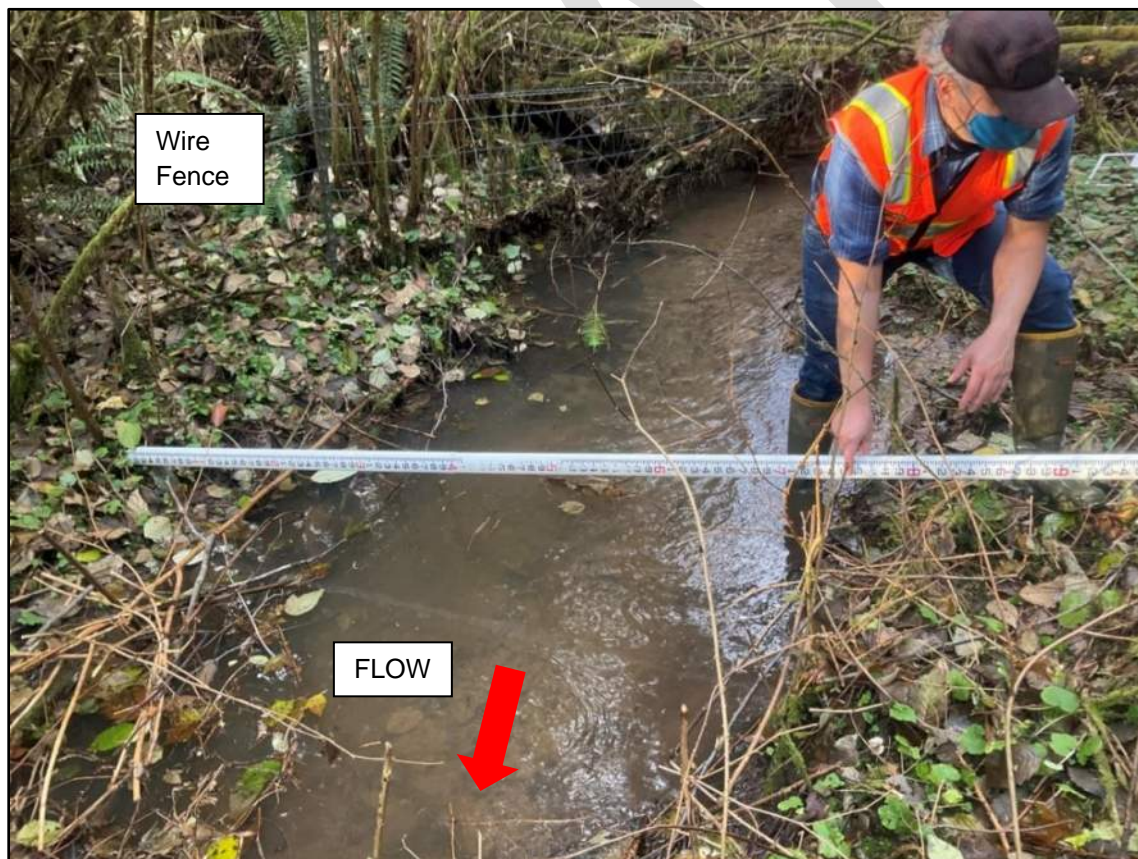
Downstream of this section, approximately between Station 1+70 and Station 0+00, the channel is overall confined (see Figure 23) and has flat overbanks. The right overbank is on private property delineated by wire fences (see Figure 24). This section also has some smaller woody material that is less than 12 inches in diameter. The vegetation in this section mainly consists of fern cover on the banks and salmonberry and some alder trees in the overstory. At some spots in this section, the channel has been partially blocked by woody material (see Figure 21), which has caused some local aggradation and loss of channel definition. At some spots, this aggradation could cause the left overbank of the channel to be accessible to high flows until the woody material is swept away, as was observed during the site visit on February 3, 2022. On the right side, a fill hillslope is present (Figure 6), which makes it inaccessible to overbank flows even at high flows, as shown on Figure 25. The stream assessment ended at Station 0+00, about 200 feet downstream of the culvert outlet.

**Figure 23: Confined channel section downstream of the culvert, with private property on the right side of the fence (approx. STA 0+70)**

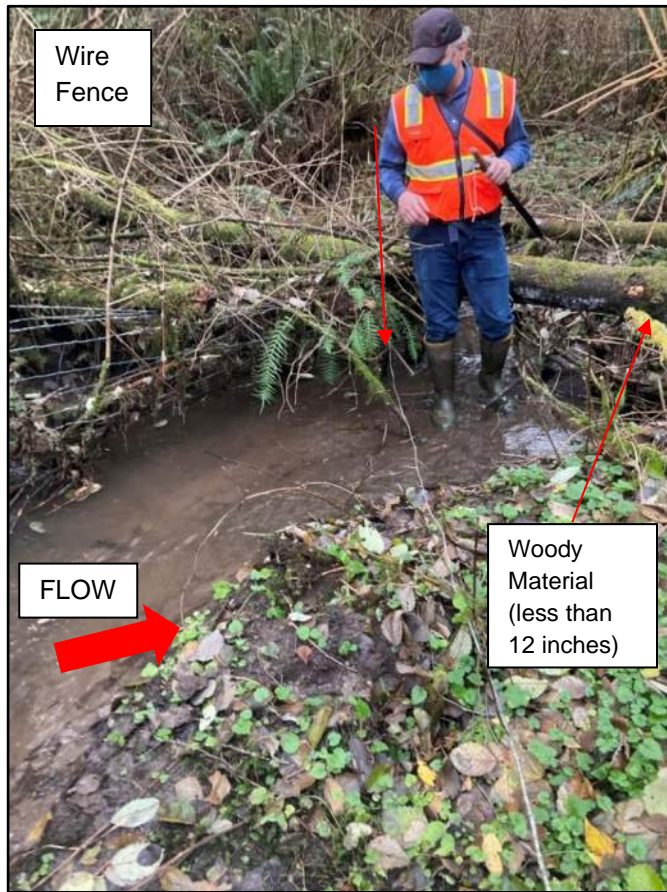
**Figure 24: Woody material and vegetation near STA 0+90**

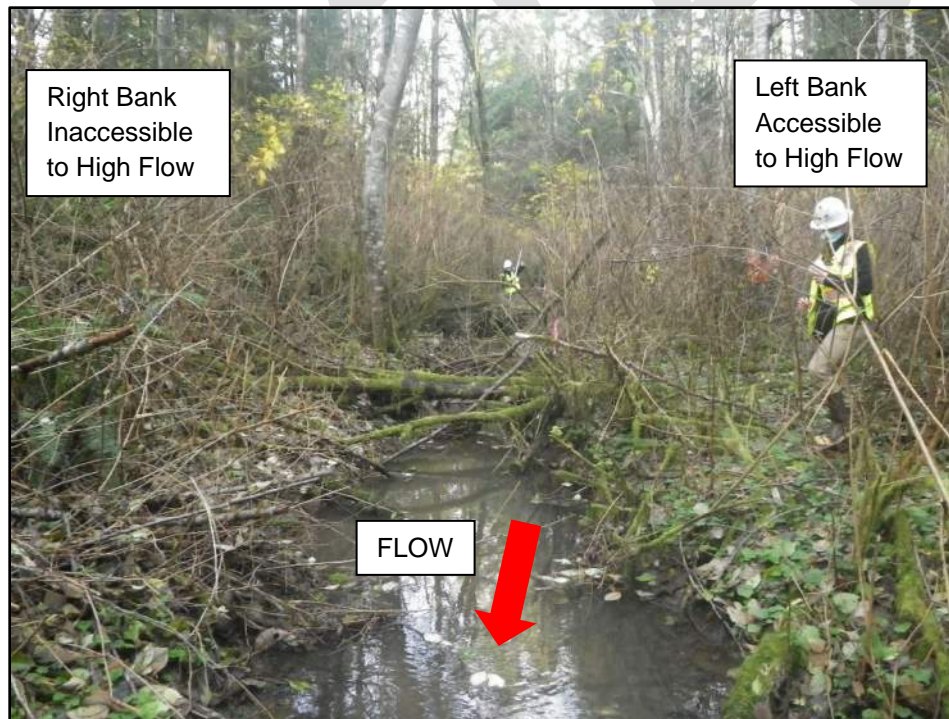
**Figure 25: View of downstream channel showing that the right overbank is a hillslope that cannot be accessed by high flows (approx. Sta 0+50)**

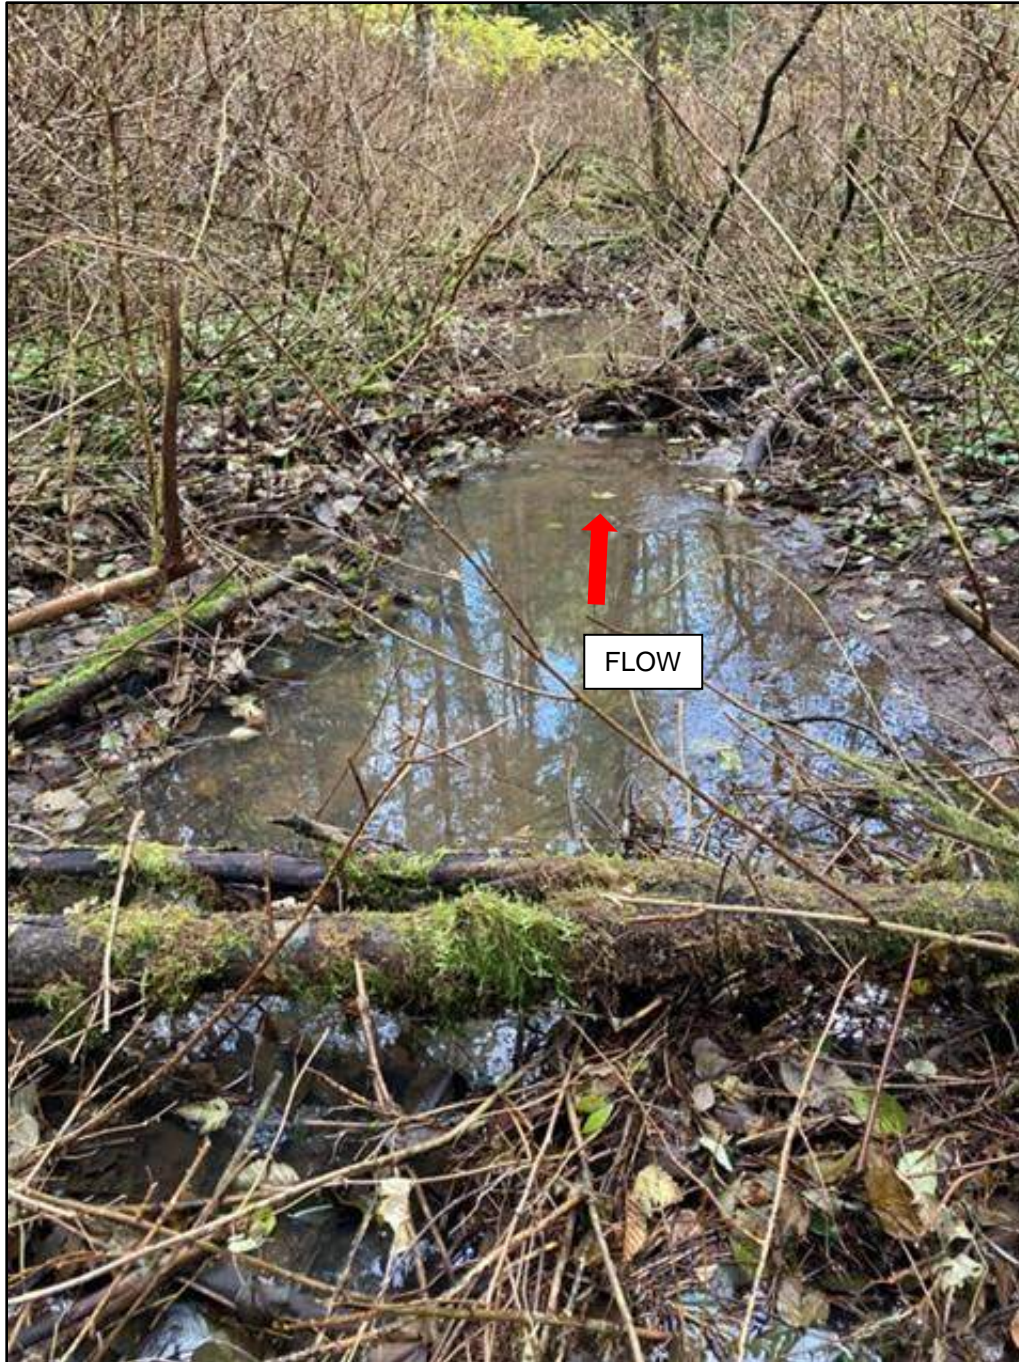
present to create periodic flow obstructions that have drops of 1 inch to 2 inches (see Figure 41). These flow obstructions typically wash out during 2-year flow events, preventing the development of permanent grade control features. The low gradient of the channel does not provide enough energy to move sediment load, thus causing deposition that makes the stream transport-limited. Sediment supply is expected to originate more from the West Tributary of the stream than the North Tributary, because the urbanized parts of the watershed generate more runoff as well as higher velocity of flow. This increased runoff and higher flow velocity can cause scour of streambed materials, thus increasing sediments to the main reach.

**Figure 41: Typical flow obstruction from woody material**

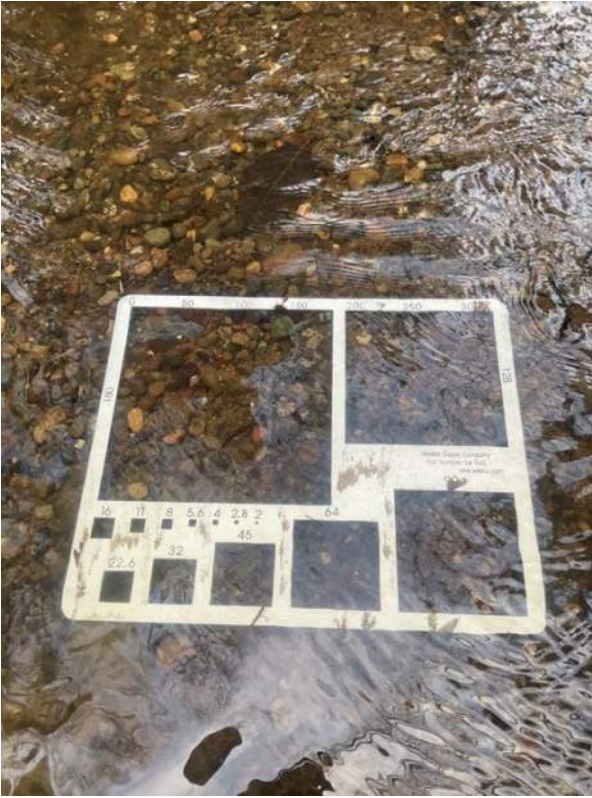
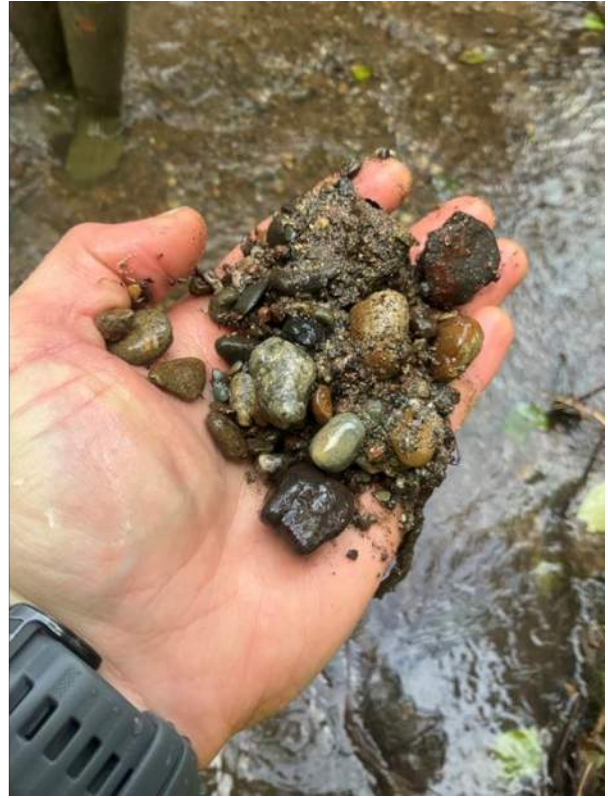
PC-1 was conducted along a length of stream approximately 135 feet downstream of the existing culvert outlet and PC-2 was conducted along the length of stream approximately 150 feet downstream of the existing culvert outlet on the reference reach. Most of the channel consisted of fines and organic matter, but there were local areas with sands and gravels that could be characterized with a pebble count. Therefore, the two pebble counts represent about 20% of the total reach with the remaining of the reach being fines. See Figure 16 for approximate sediment dimensions and distribution at site PC-1. See Figure 17 for approximate sediment dimensions and distributions at site PC-2. These pebble counts represent the coarser material that is present and can be mobilized if the channel were to be more channelized similar to the reference reach.

*Figure 17 PC-2 location: sediment w/ gravelometer and sediment in Hand*

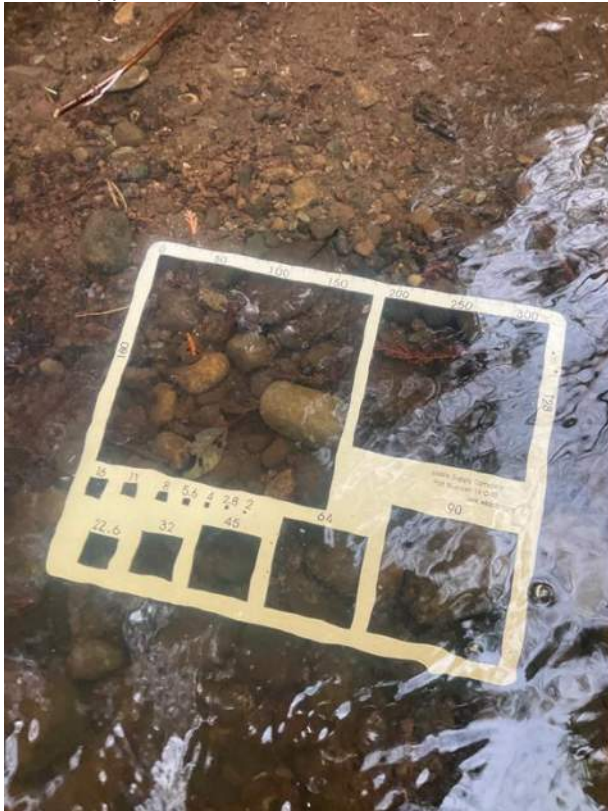
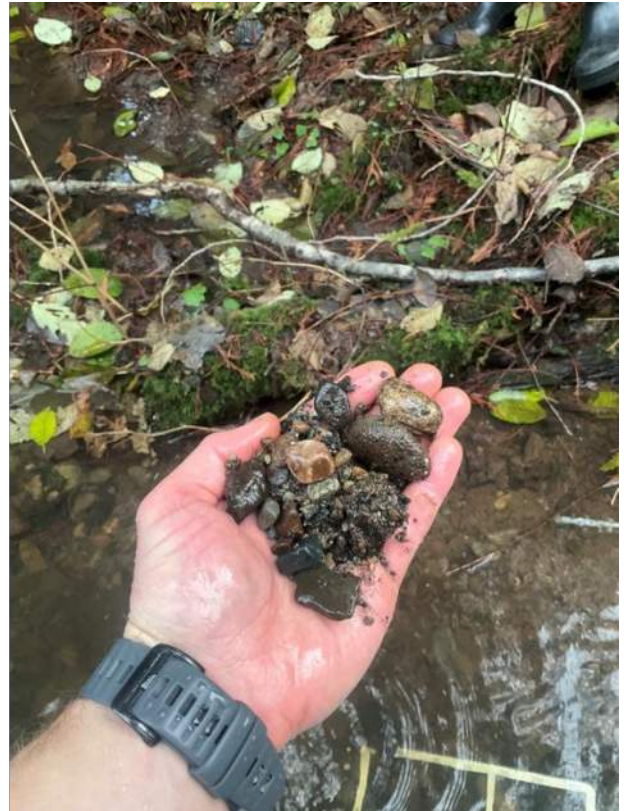
PC-3 was conducted along the length of stream approximately 240 feet upstream of the existing culvert inlet within the reference reach. The sediment here consisted of a generally sand sediments with some coarser materials. See Figure 18 for approximate sediment dimensions and distributions at site PC-3.

*Figure 18 PC-3 location: sediment w/ gravelometer and sediment in hand*

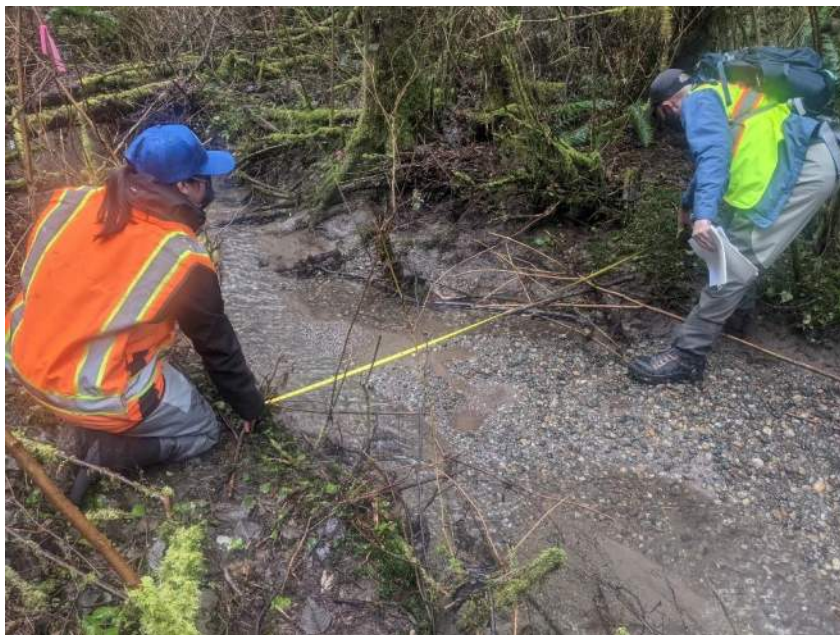
Two bank-full widths were measured in the reference reach. Both measurements showed that the BFW was 8 feet wide.

Figure 19: Bank-full width measurement within reference reach.

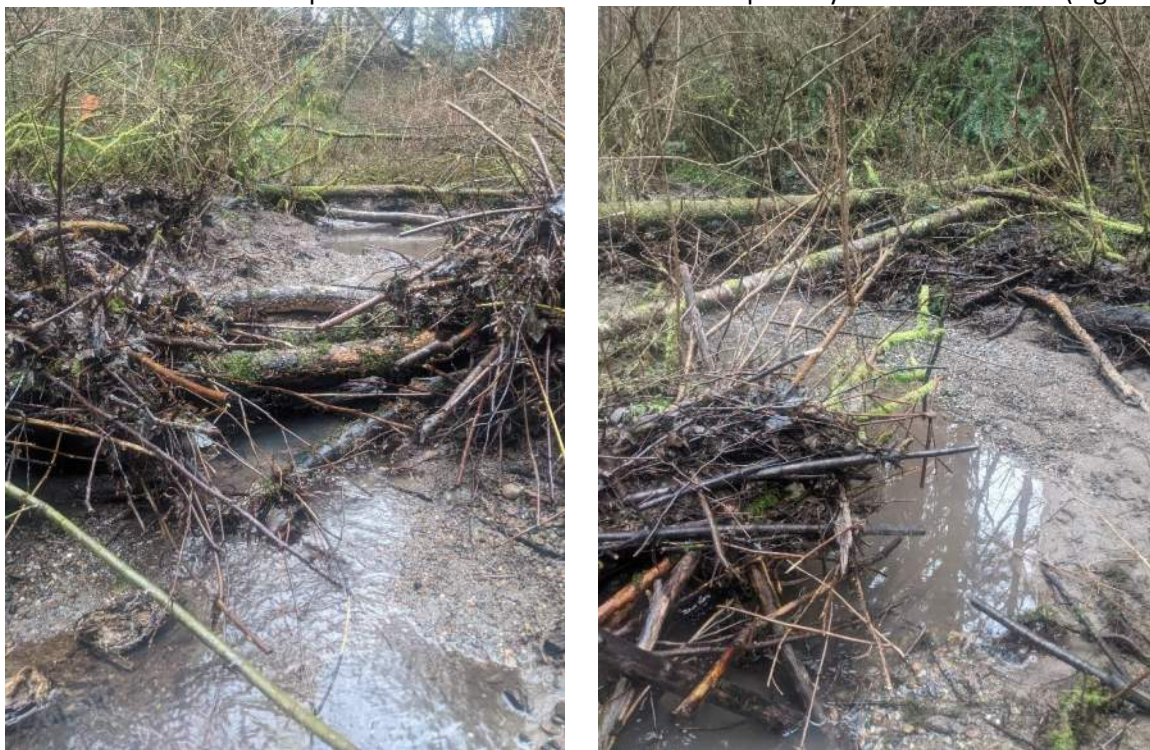
There were lots of mid-sized (6 to 12-inch diameter) woody debris in channel forming small steps 6-12 inches in height. Some of the small debris drops seen in earlier site visits were swept away at some locations (Figure 23).

*Figure 23: Woody debris in the channel (LEFT) and Debris drops removed by the high flow event (RIGHT).*

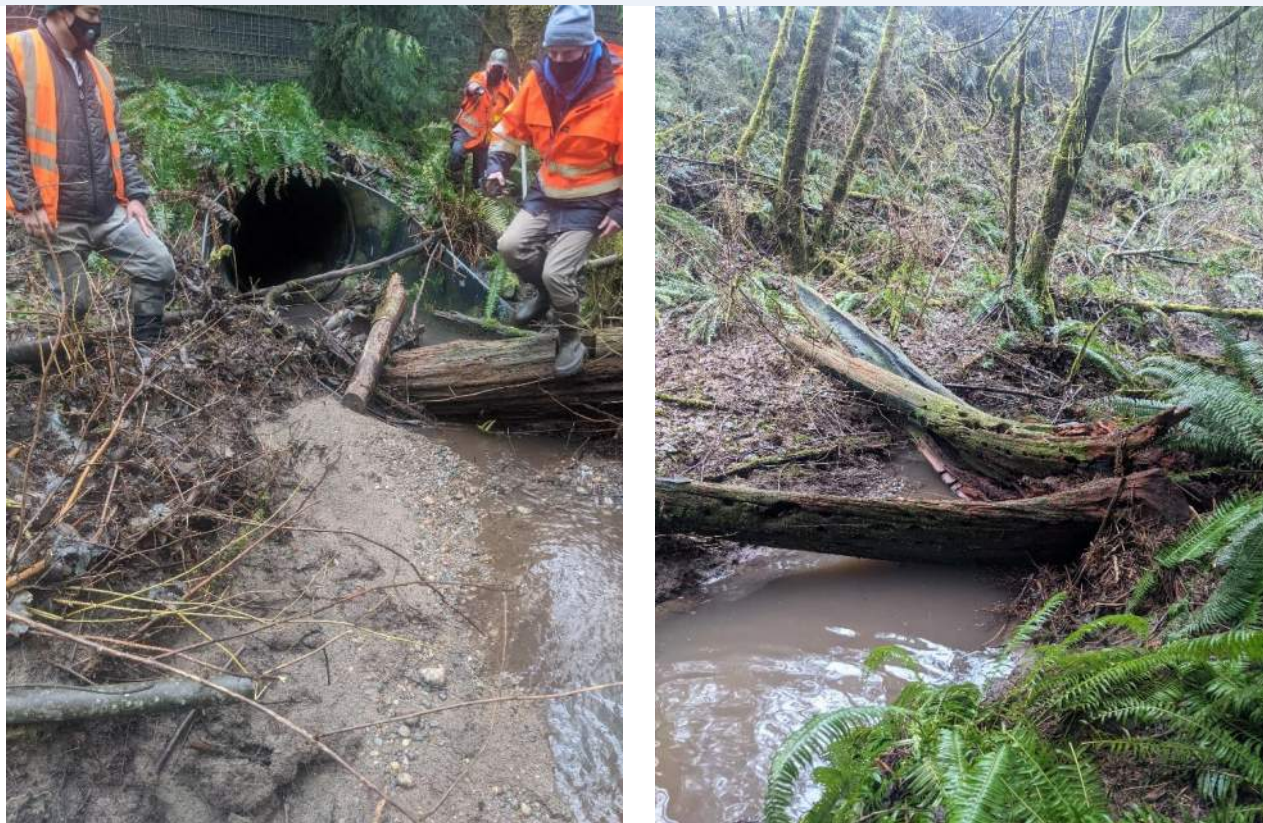
*Figure 24: Trees and vegetation fallen from the recent storm event. The tree on the right was a part of vegetation on the reference reach.*
